The International Compendium for Crash Research

TESLA EDR CASE STUDIES & RECONSTRUCTION TECHNIQUES

WESTON BROWN & ROBERT D ANDERSON

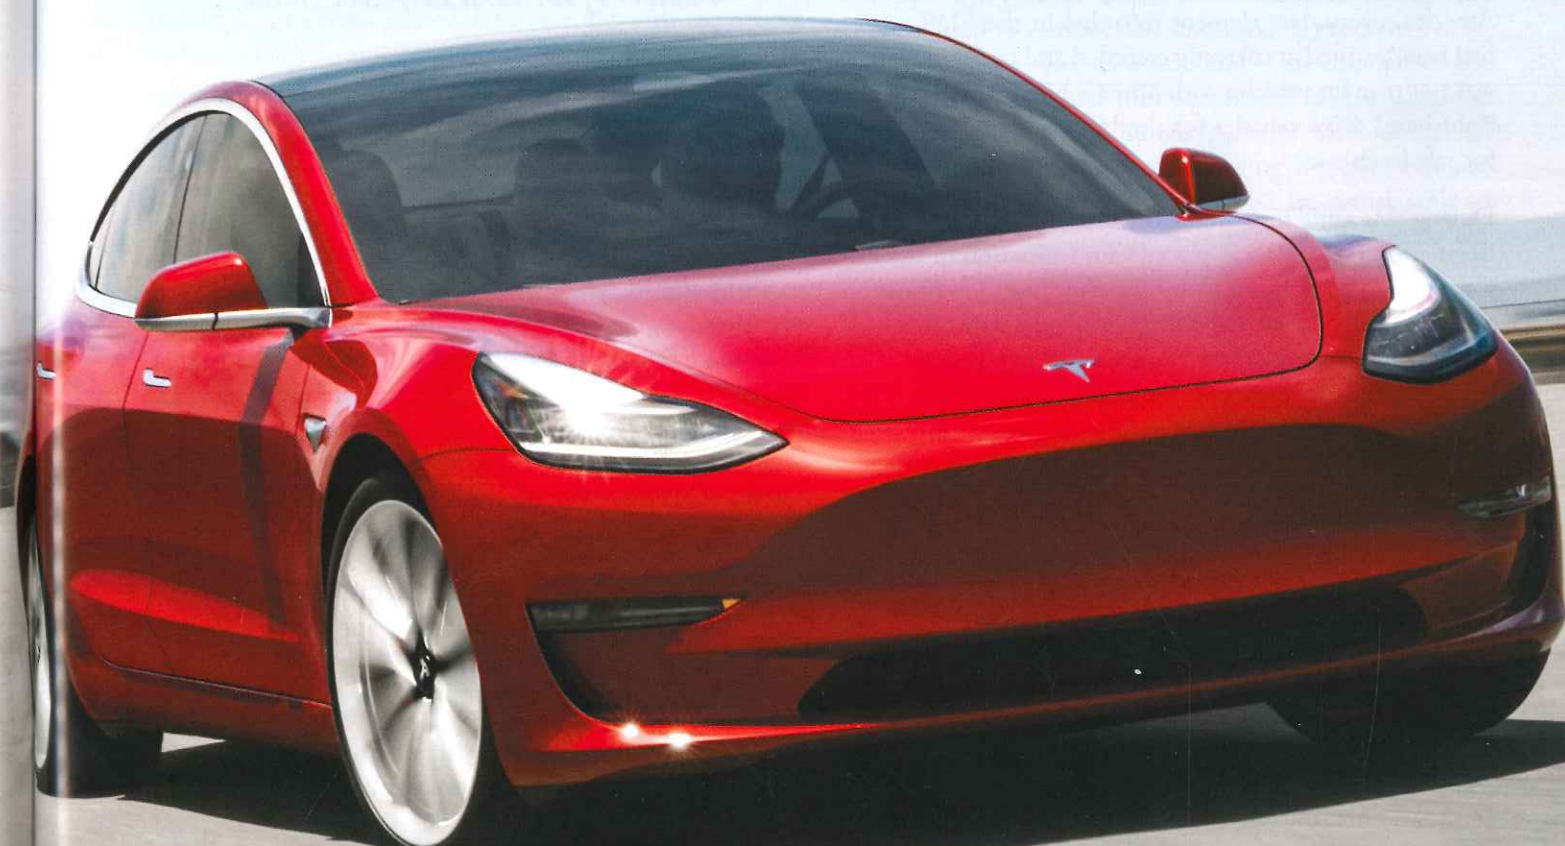
Unlike the Bosch CDR Tool software, which translates the data and creates the report on your computer, the Telsa *.edr file is uploaded to Tesla via the Online EDR Reporting Service Portal (<https://edr.tesla.com/>) and is automatically processed with the most recent translation. An EDR report is generated in an Adobe (pdf) file to be downloaded to your computer. This process typically takes about half a minute, depending on your connection speed. Like the *.CDRx file in the Bosch CDR Tool, the original Tesla *.edr file should be saved so that it can be retranslated to verify that the translation has not changed prior to testimony, etc.

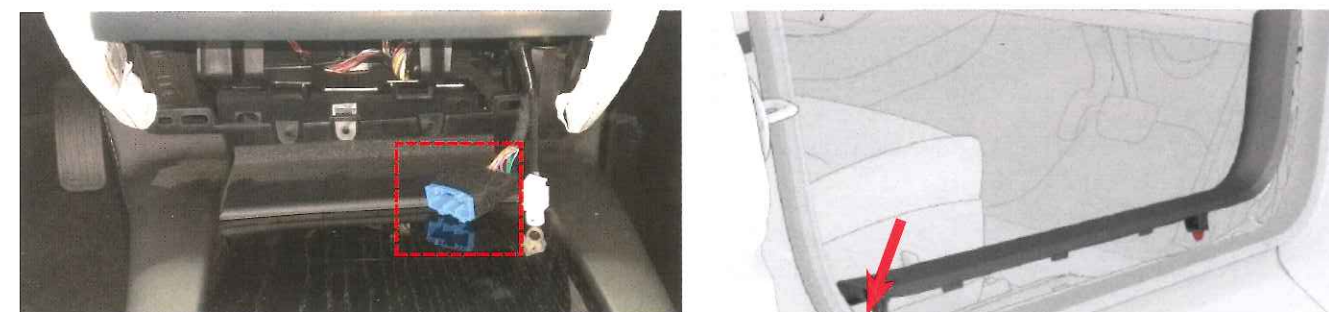
Figure 5: In vehicle connector locations for Tesla Models S and X (left) and Tesla Model 3 (right)

Analogous to a DLC/OBD II connection, the CAN bus access point can be used to establish an in-vehicle connection in order to perform a crash data retrieval via one of the vehicle's three CAN bus networks without physically accessing the RCM. As shown in Figure 5, the Model S and Model X, the CAN bus receptacles are located behind the storage pocket under the touch screen and the Model 3's CAN bus receptacle is located beneath the passenger door sill cover strip by the base of the B-pillar. For the Model 3, the receptacle must be released from the wiring harness before the in-vehicle cable can be plugged in, and then replaced before the vehicle can be driven again.

Once the vehicle communication harness is located, the *.edr data is retrieved by attaching the appropriate cable to

the PCAN adapter and retrieving data through the Tesla EDR software.

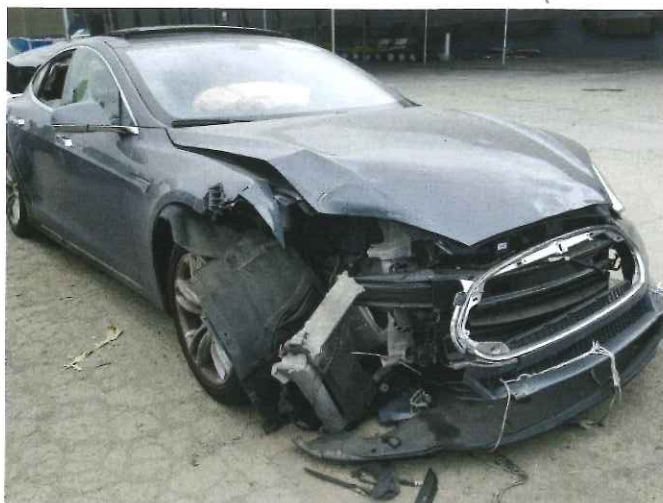
Figure 7: 2013 Model S – Case Study #1

In the first case study, data was retrieved direct-to-module from a 2013 Model S involved in a crash where it sustained damage to the right front and the left rear side (Figure 7). There were two events recorded that were 2.6 seconds apart (Figure 8).

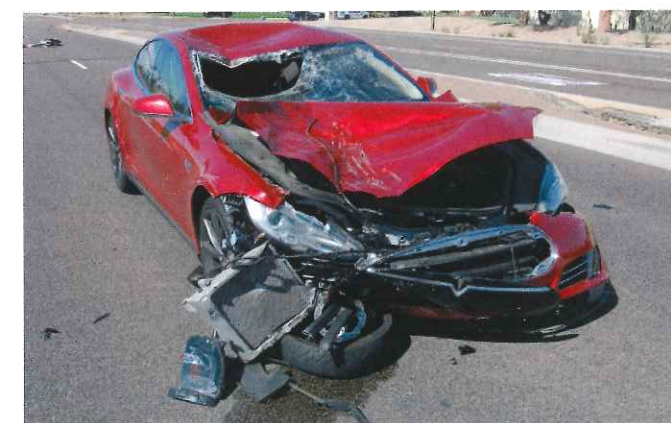
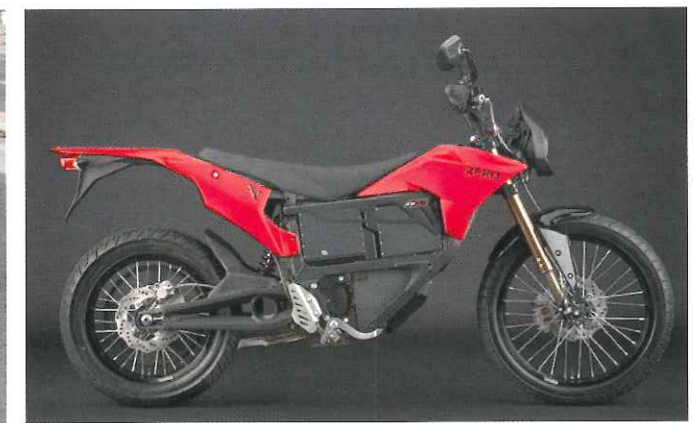
Figure 11: The 2014 Model S and an exemplar 2016 Zero SR

The Tesla Model S had significant damage to the front end, focused primarily to the right side of the vehicle (Figure 11). None of the wheels were locked due to damage. Based on damage to the windshield it is evident the motorcycle rider left the motorcycle and rode up onto the windshield and roof of the Tesla where he then departed the vehicle. The motorcycle rear wheel assembly was re-

moved from the motorcycle as it departed the crash and remained wedged under the front of the Tesla.

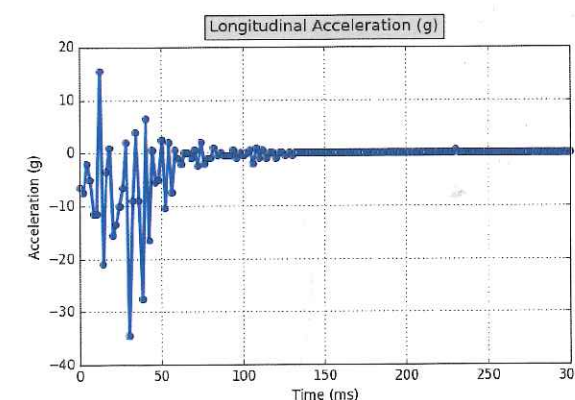
Figure 21: Tesla EDR vehicle acceleration

Fortunately, the Tesla EDR report contains information that is useful for this type of analysis. In addition to the ΔV graph, the Tesla EDR report provides a graph of the vehicle's impact acceleration, as shown in Figure 21. This is useful for determining when the crash pulse ends in order to evaluate if the entire crash pulse was recorded.

Any additional ΔV that was measured after the crash pulse ended can be removed after the crash pulse end evident in the acceleration graph. As with any threshold activated recorder, it is possible to miss a small amount of ΔV due to the sub-threshold acceleration preceding module wake-up, but this is generally small, or even negligible for impacts outside the realm of low speed. The presence or absence of the clipping flag indicates if data clipping occurred.

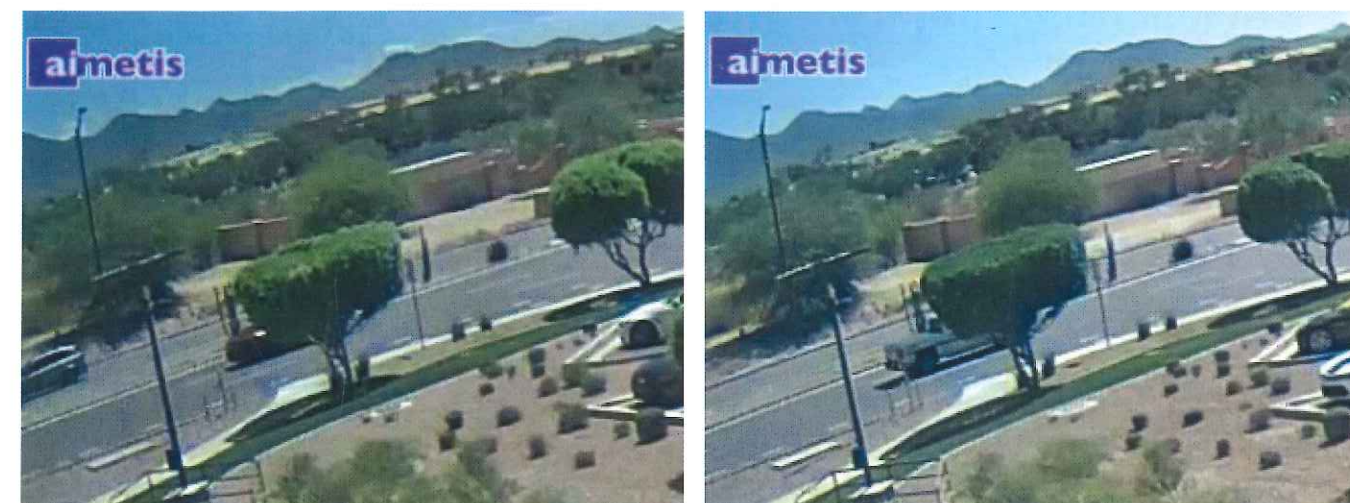
Figure 27: Surveillance video frames shown the Tesla and patrol vehicle at a comparable location

Roadway evidence was used to determine the point of impact and a frame by frame review of the video was utilized to determine a specific location for the Tesla from which a distance to the area of impact could be used for a time distance speed calculation. This was accomplished by placing a patrol vehicle in a location comparable to that of the Tesla captured in a frame of the surveillance camera video. Figure 27 shows two video frames, representing the patrol vehicle at the same location as the Tesla.

The distance measured from the patrol vehicle to the area of impact was 357 feet. The frame rate of the raw video data was determined to be 5 frames per second. The video evidence was then again reviewed frame by frame to determine the frame nearest the collision. This was determined to be frame 813 and can be seen in Figure 28. Once this

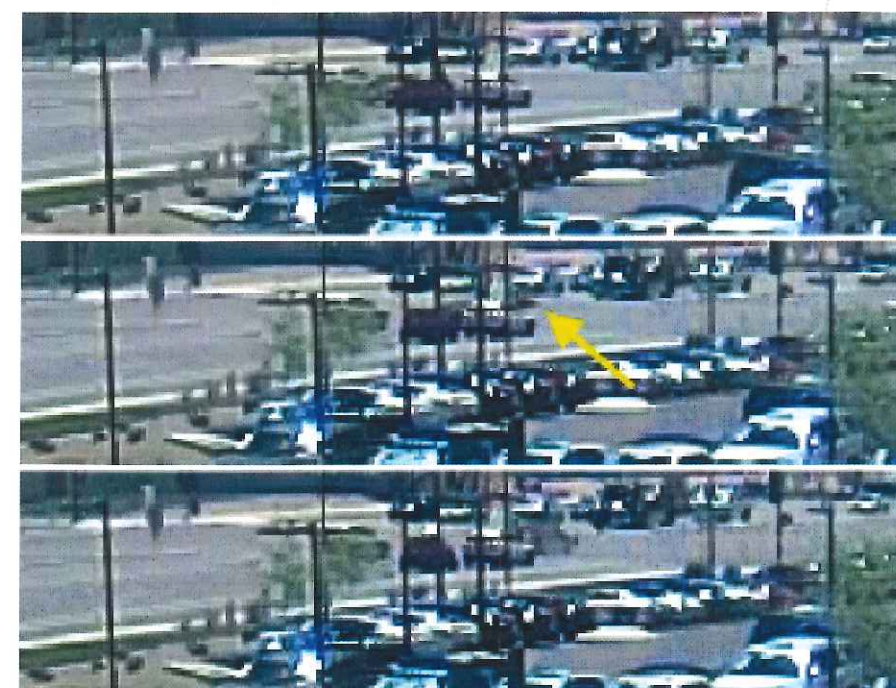
Figure 28: Collision depicted in surveillance video frames

was accomplished, Input Ace, Video specific software, was utilized to verify the exact time between frames as well as the time from frame 800 to frame 813. This was determined to be 2.6 seconds. This allowed a simple time distance calculation. Accounting for possible errors in time associated with one frame, and +/- 5 feet for impact location results in an average speed within the range of 86 to 103 mph over the 2.4 to 2.8 seconds preceding the collision.

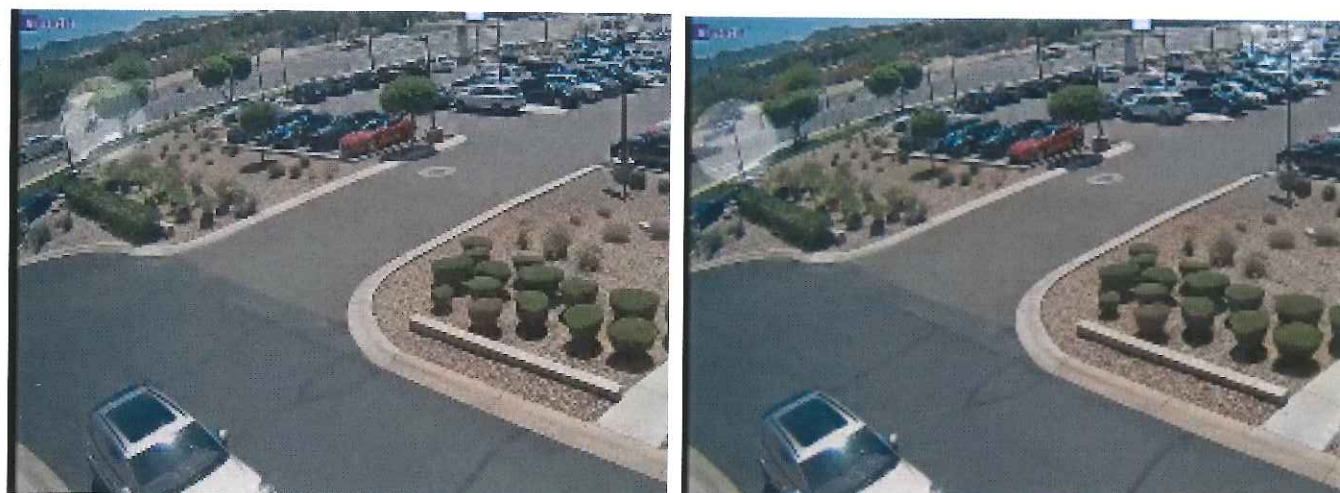
Figure 26: Surveillance video frames showing the appearance of the motorcycle and Tesla

Every investigation includes a search of the area for potential surveillance camera footage. This led to a video recording of the event obtained from a dealership bordering the roadway where the collision occurred. Figure 26 shows video frames depicting the appearance of the motorcycle and the Tesla. The video shows the motorcycle come to a stop at the intersection and then moments later, the red Tesla approached the intersection at high speed and collided with the motorcycle and rider.
